#### AFPTEF REPORT NO. 96-R-01 AFPTEF PROJECT NO. 93-P-107

Research Testing of Commercial Retractable Handles for Small Containers

AFMC LSO/LOP
AIR FORCE PACKAGING TECHNOLOGY AND ENGINEERING FACILITY
WRIGHT PATTERSON AFB, OH 45433-5540
January 1996

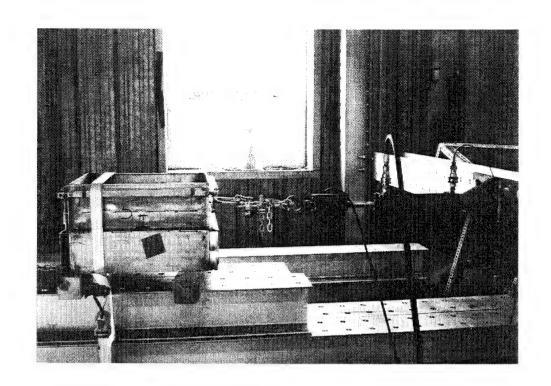
The container is secured to the floor and the handles are pulled in four different directions using a hydraulic tensile tester, see Figure 1. The four directions are described in the test plan, Attachment 1. The pulling force starts at 50 Kg  $\pm$  2 Kg and increase in increments of 10 Kg  $\pm$  2 Kg. At each 10 Kg increase, the handle is visually inspected and measured for bending and/or

Figure 1. TEST SETUP.

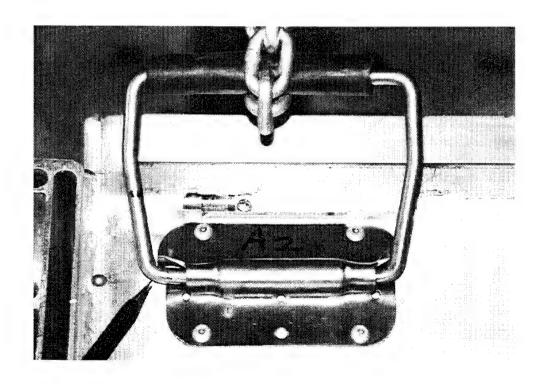
- $\bullet$  80 Kg, the handle functioned normally with an increase rotation up to  $105^{\circ}$ .
- 100 Kg, the handle functioned normally with an increase rotation up to 112°. The physical stop started to show slight deformation, see Figure 2.
- 130 Kg, the handle functioned normally with a rotation of  $112^{\circ}$ .
- 160 Kg, the handle functioned normally. The bail flexed past the physical stop. This changed the angle the applied force was pulling.
- 200 Kg, the handle functioned normally.
- 220 Kg, the handle is starting to show signs of deformation.
   The spring action is a little hampered.
- 250 Kg, the handle came in contact with the container when the load was applied, see Figure 3. The spring action failed to return the bail completely back against the container wall.

Figure 2. PHYSICAL STOP DEFORMATION.

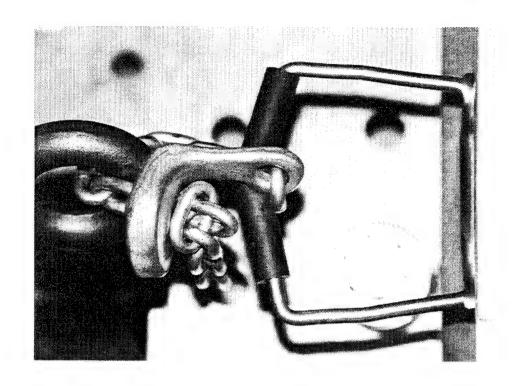
- 200 Kg, the handle functioned normally. When load applied, the bail flexed 10 mm.
- 250 Kg, the handle functioned normally. When load applied, the bail flexed 10 mm. The force was increased.
- 350 Kg, the handle functioned normally. The spring action is slightly hesitant, but retracts the bail completely.
- 400 Kg, the handle functioned normally. Spring action still hesitant. When load applied, the bail flexed 15 mm.
- 420 Kg, the handle functioned normally. Spring action hesitation is increasing. Bail starting to show signs of deformation, see Figure 4.
- 430 Kg, spring action more hesitant and not completely returning bail to container wall. Bail deformed.
- 460 Kg, spring action failed to return the bail to the container wall. Bail deformed 25 mm.

be the bail being bent in the area where the spring wrapped around the bail. This caused friction between the bail and spring and didn't allow the spring to retract the bail.

Figure 4. BAIL DEFORMATION.

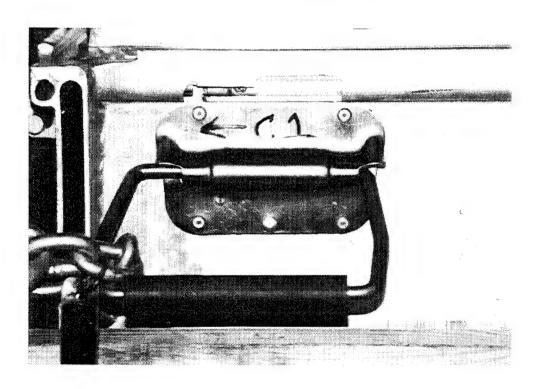
- 120 Kg, spring action hesitant. Bail starting to show signs of deformation, see Figure 5.
- 140 Kg, spring action failed. Bail deformed, see Figure 6.

Figure 5. BAIL SHOWING SIGNS OF DEFORMATION.

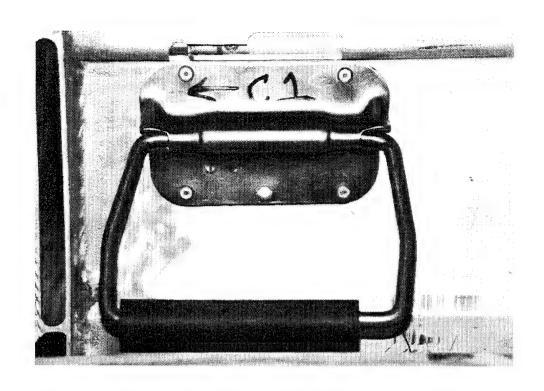
The handles performed well. The handles were removed from the container and inspected. The cause of the spring failure for Tests C1 & C2 was determined to be the bail pulled out beyond the spring. This allowed the tension in the spring to be released. In Tests A & B the cause of the spring failure was determined to

Figure 6. BAIL DEFORMATION.

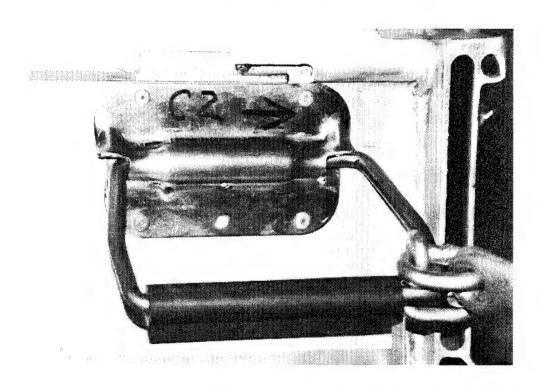
- 120 Kg, the handle functioned normally.
- 150 Kg, bail showing signs of deformation, see Figure 7. Spring action is normal.
- 170 Kg, spring action hesitant. Bail deformed, see Figure 8.
- 180 Kg, spring action more hesitant.
- 200 Kg, spring action failed.

Figure 7. BAIL SHOWING SIGNS OF DEFORMATION.

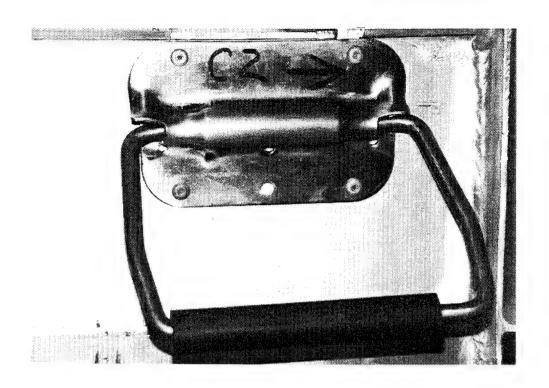
Figure 8. BAIL DEFORMATION.
